## Lessons Learned in the Field

# Beware the Obvious Conclusion!

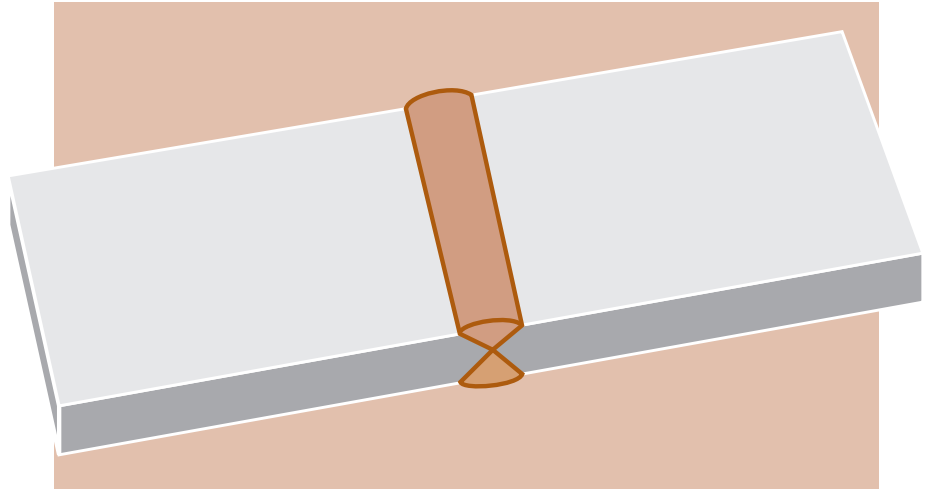
Figure 1. Test plate with flange splice.

Together with the customer, I carefully reviewed the possible causes. The CJP groove weld was on a 1-5/16 in. (33 mm) thick plate (Figure 1), so the potential for high residual stresses existed. I also thought we might be picking up some alloy out of the base material. This scenario led me to rec-

ommend slowing down the cooling rate through increasing preheat and interpass temperature, trying to minimize the influence of the base metal on the weld deposit.

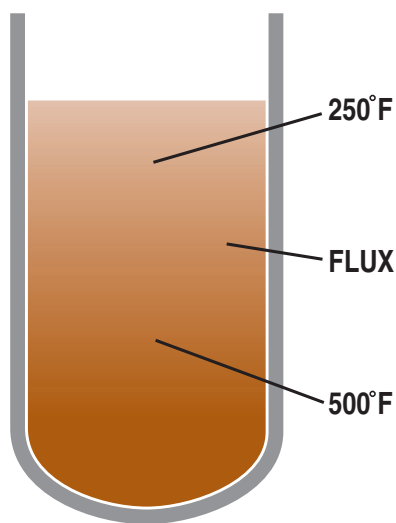
Figure 2. A flux holding oven.

- Low winter time ambient temperature in the unheated shop
- Flux was being heated in a holding oven (Figure 2), rather than in a true flux drying oven
- The welding set-up would not permit access to the bottom of the plate for heating

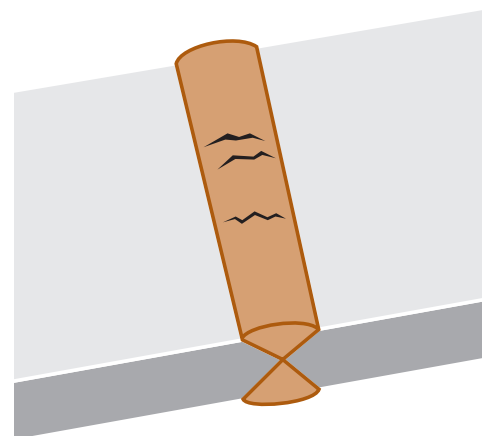
Sections of the failed welds were distributed to the Federal Highway Administration, Lincoln Electric, and the steel supplier for analysis. After returning to our Welding Technology Center, I subjected my sample to a full array of metallographic tests in our lab. Upon analyzing the results, Marie Quintana, Lincoln's Manager of New Products, Consumables, felt that we were dealing with a case of hydrogen assisted cracking in the LA100 filler metal (Figure 3). This was something I hadn't considered. My twenty years of

having a cracking problem, the steel is to blame. But this time, my assumptions had misled me. The problem was actually due to the susceptible chemistry of the weld.

Figure 3. Weld sample with hydrogen assisted crack.

It turned out that on the third attempt at the weld, our team effort to supply more than sufficient preheat, to maintain interpass temperature and to

meticulously condition the flux had actually overcome this tendency to hydrogen assisted cracking. Even after several days, no cracks appeared. At that point, the customer and the Federal Highway Administration were satisfied.

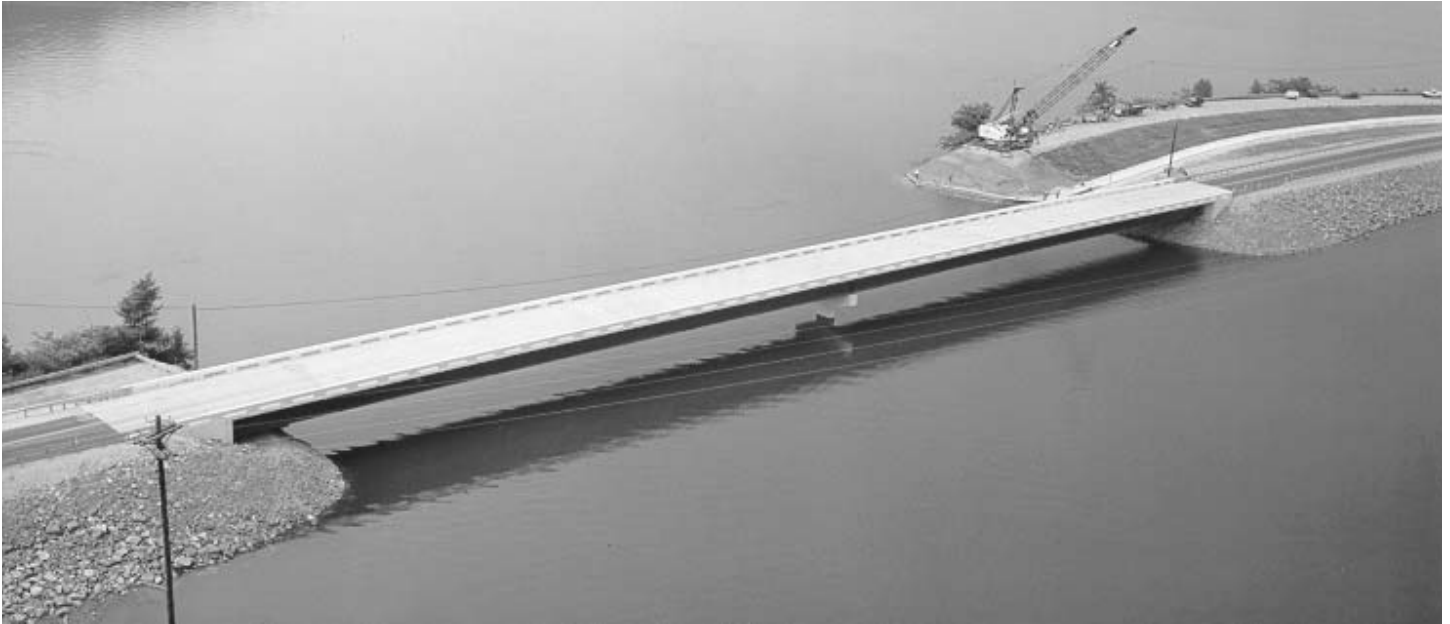
Figure 4. Girders for highway bridges such as this one require multi-pass CJP groove welds.

entailed small, single pass welds—situations that were very different from this multi-pass CJP weld on a relatively thick bridge girder such as the one shown in Figure 4.
